A Tale of Three Winters: Repeated Extreme Event Damage Along the **Central California Coast**

Gary Griggs* and Lida Davar

Griggs, G. and Davar, L., 2025. A tale of three winters: Repeated extreme event damage along the Central California Coast. Journal of Coastal Research, 41(5), 892-906. Charlotte (North Carolina), ISSN 0749-0208.

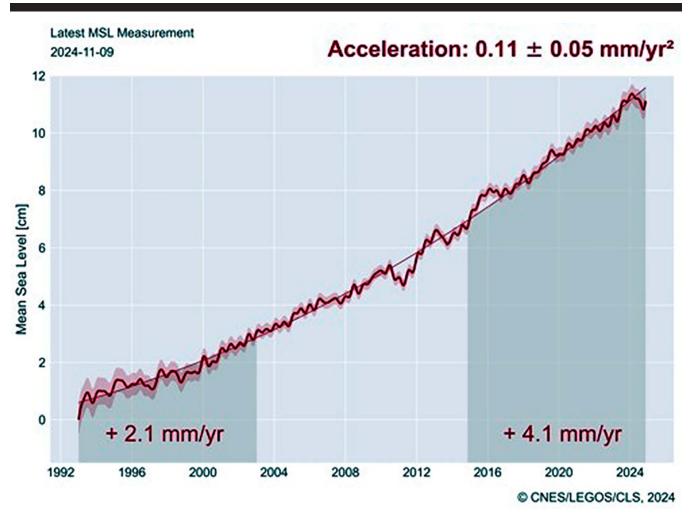
Figure 1. Accelerating rate of mean global sea-level rise (AVISO, 2025).

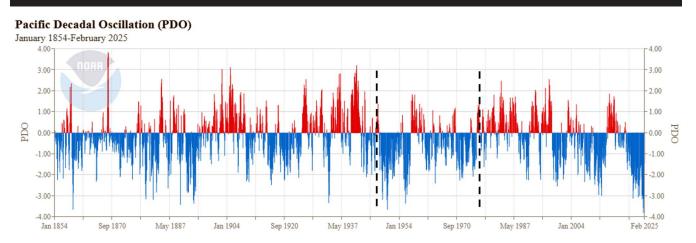
Figure 2. Pacific Decadal Oscillation history from January 1854–January 2025. Blue represents cooler (and calmer) conditions along the West Coast and red is indicative of warmer and generally stormier conditions with more frequent and stronger El Niño–Southern Oscillation events. Note the shift around 1945 to calmer or cooler conditions (blue) and then a shift to warmer, stormier conditions (red) around 1978 (NOAA NCEI, 2025).

With the shift to a warmer PDO interval in about 1978 (see Figure 2), the combination of more frequent and stronger El Niño events (Figure 5), which elevated sea levels as much as a foot or two (Table 1), combined with large storm waves from the SW arriving at times of high tides to severely affect shoreline development along northern Monterey Bay (Griggs, 2018). In particular, the shoreline village of Capitola

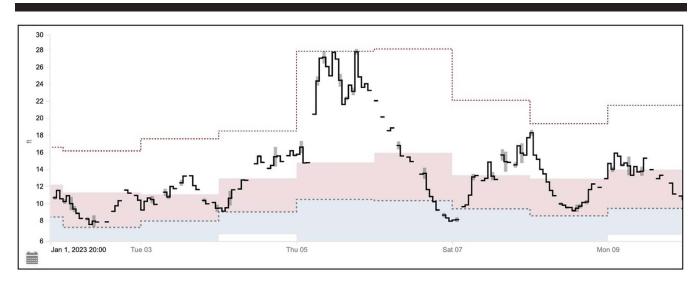
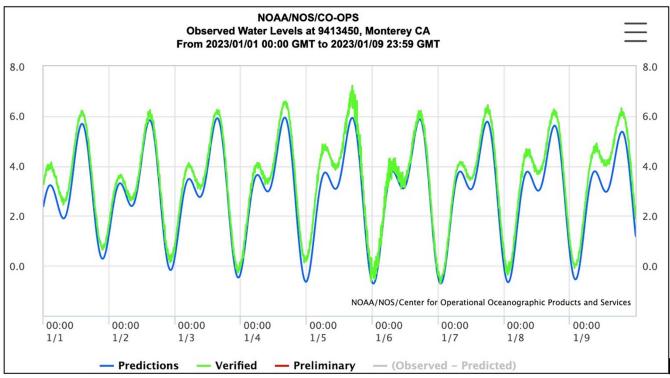
Figure 9. Simultaneous arrival of very large waves (top) and high tides (bottom) on the morning of 5 January 2023. Wave data from Coastal Data Information Program buoy no. 46042 (NOAA National Data Buoy Center; https://www.ndbc.noaa.gov).

Program [CDIP] wave buoy no. 46042). Significant wave heights on the morning of 5 January 2023 reached approximately 28 ft. These waves were from the WSW (255°) and approached this section of shoreline more directly with less energy loss from refraction than the typical NW winter storms. The nearest tide gauge in operation at that time was mounted on the Monterey Breakwater and is located 25 miles south of Santa Cruz (NOAA gauge 9413450). High tide that morning was predicted at 5.93 ft, but actual maximum verified high water was 7.22 ft (Figure 9), 1.3 ft above predicted water level.

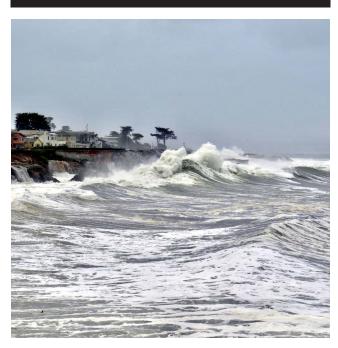
Figure 10. Large waves at high tide affecting the bluffs along West Cliff Drive on the morning of 5 January 2023.

The West Cliff Drive area (see Figure 3) is most exposed to the waves from 255° and was severely affected by the largest waves (Figure 10). This section of coast is backed by an uplifted marine terrace ranging from 20 to 30 ft in height and consists of pervasively jointed siltstone/mudstone bedrock capped by 10–12 ft of poorly consolidated and very erodible terrace deposits (Figure 11). Wave damage to the West Cliff Drive area was as severe as any prior winter on record as large waves at high tide overtopped the bedrock, eroded the unconsolidated terrace deposits, and led to collapse of several sections of the pedestrian walkway and began to undercut the roadway (Figure 12).

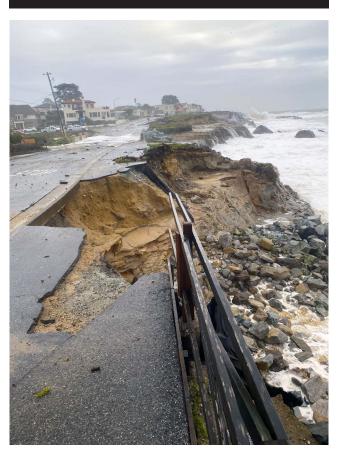
Figure 12. Erosion of unconsolidated terrace deposits, loss of pedestrian sidewalk, and undermining of West Cliff Drive in city of Santa Cruz on 5 January 2023.

Figure 20. Excavation and site preparation for seawall construction along West Cliff Drive in Santa Cruz after January wave damage (November 2023).

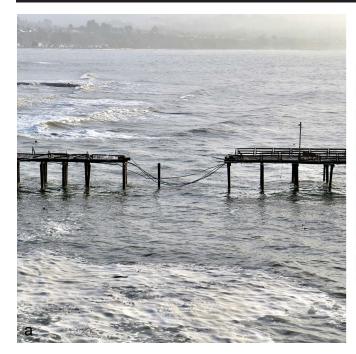
Figure 13. (a) Collapse of a portion of the pier at Capitola on 5 January 2023. (b) Flooding of an oceanfront restaurant and damage from timber and other debris from the collapsed pier (photo credit: Kevin Painchaud, Lookout Santa Cruz).

Six miles down the coast to the east in the shoreline village of Capitola (see Figure 3), a portion of a pier collapsed (Figure 13a), and restaurants along the oceanfront esplanade were flooded and damaged as large timbers from the partially collapsed pier were carried through the outer walls and left inside one restaurant (Figure 13b). Waves washed across the beach, battering and flooding (Figure 14) beach-level apartments and commercial establishments causing major damage from wave attack and flooding. This was not the first time that the shoreline village of Capitola had experienced

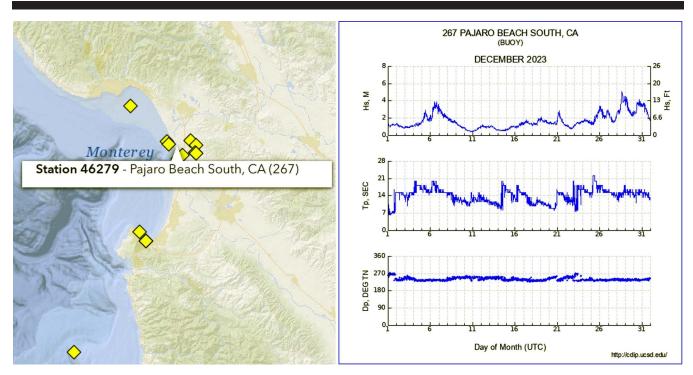
Figure 19. Wave conditions in late December 2023 at Coastal Data Information Program buoy 267 (Pajaro Beach South) (NOAA National Data Buoy Center, 2025; https://www.ndbc.noaa.gov/station_page.php?station=46279).

tides that caused significant coastal flooding and erosion (Timmerman, 2024). Unfortunately, storms earlier in December had broken loose the wave buoy off Monterey Bay so no data were recorded. On 28 December 2023, the closest other CDIP buoys documented maximum wave heights of 5.7 m (18.7 ft) at Pajaro Beach South (Figure 19), 15.8 m (51.7 ft) at Cape Mendocino, 270 miles north, and 15.4 m (50.4 ft) at Point Sur, 45

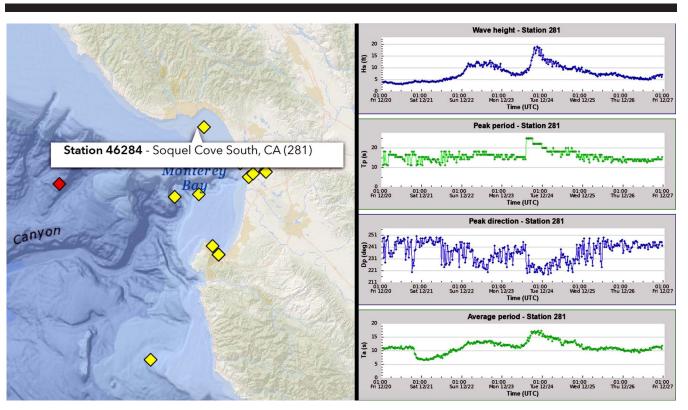
Figure 25. Wave conditions in late December 2024 at Coastal Data Information Program buoy 281 (Soquel Cove South) (NOAA National Data Buoy Center, 2025).

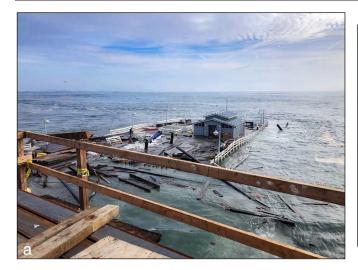
Figure 26. (a) Outer end of the Santa Cruz pier after collapsing into the ocean on 23 December 2024 (photo credit: Brad Porter, City of Santa Cruz). (b) Restroom from end of municipal wharf was carried intact where it floundered on the beach at the mouth of the San Lorenzo River (courtesy of: Kevin Painchaud, Lookout Santa Cruz).

under construction, the outer 150 ft, with its public restroom, collapsed into the large swells. This process occurred slowly enough that two engineers went down with the decking, still standing up, along with two pieces of heavy equipment (Figure 26a). They were soon rescued without injury while the nearly intact section of the pier decking and the restroom drifted toward the beach where it floundered at the mouth of the San Lorenzo River before being demolished and removed (Figure 26b). The destruction of the outer end of the pier and the estimated \$20 million replacement cost led the city of Santa Cruz to rethink their plans to rebuild the destroyed section and build a major public structure at the outer end of the pier. Loose pilings and large timbers from the collapsed section of the pier were carried down the coast as far as 12 miles, creating a severe hazard for anyone in the water, including surfers as well as vessels.

Resistance along this shoreline can involve the use of protective devices such as seawalls or rock revetments, and rebuilding structures such as piers stronger to resist future wave attack. This approach may be appropriate if the protection is deemed to be cost effective for a reasonably long period and the asset is highly valued. This has been the historical approach used for the damaged and threatened portions of West Cliff Drive in Santa Cruz, where about \$35 million has been spent to armor the damaged sections of the intensively used roadway. Over 50% of the city's coastline has now been armored and most of the 2023 winter damage was in locations already protected by rock revetments, which either collapsed or were overtopped. In the village of Capitola where a portion of their pier was destroyed during the January 2023 storms, a decision was made, on the basis of the importance of this iconic structure to the community, to rebuild the pier.

The future or fate of two of the most damaged structures, the Santa Cruz Municipal Pier and Seacliff State Beach, is still being evaluated. Early indications are that after seven episodes of rebuilding the timber bulkhead and RV camping and public parking areas on the beach, followed by destruction, the California Department of Parks and Recreation is rethinking this approach and giving serious consideration to providing these same use opportunities on the bluff top above the shoreline. Discussions to date regarding the original plans to build a large public structure on the now-destroyed outer end of the Santa Cruz Municipal Pier have thrown this project into question. In both cases, these projects may likely fall into the relocation approach.

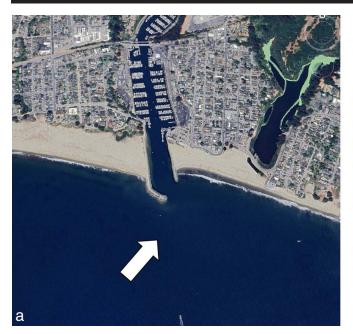
Figure 27. (a) Santa Cruz Small Craft Harbor with direction of wave approach on 23 December 2024 (Google Earth). (b) Damage to boats and docks at the Santa Cruz Small Craft Harbor from 23 December 2024 waves (courtesy of: Keven Painchaud, Lookout Santa Cruz).

The other facility that had significant damage during the late January swells was the Santa Cruz Small Craft Harbor. The harbor is now 60 years old and had been damaged by three tsunamis since its completion in 1964 (Griggs, 2018). Because in large part of the configuration of the entrance jetties (Figure 27a), it had never been seriously affected by waves. The large waves on 23 December 2024, however, washed into the harbor and battered boats and docks. The harbor sustained about \$25 million in damage, as at least 12 boats reportedly sank and many others were damaged (Figure 27b). The closest wave gauge indicated that waves at the time of greatest harbor impact were from ~220° (see Figures 25 and 27a). It appears that because of a combination of wave refraction and diffraction, waves still had enough energy to produce major damage within the normally protected harbor.
